COOLING A HUDSON STEPDOWN ENGINE

Ken Cates - 14 December 2018

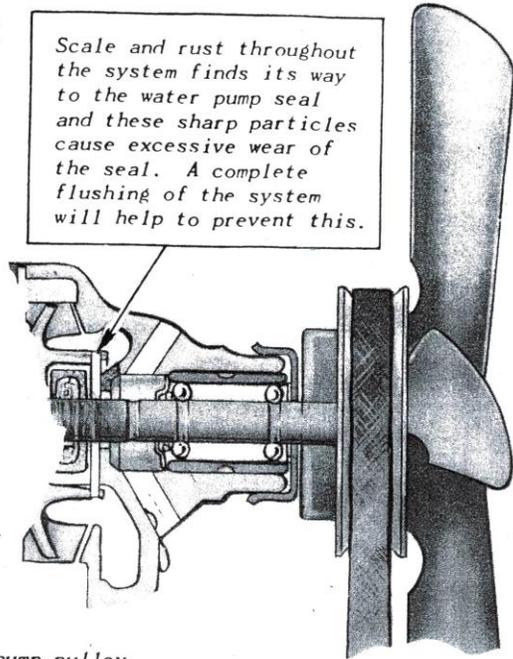
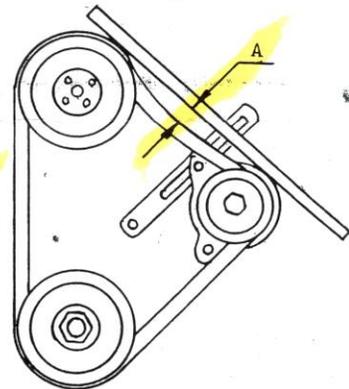
The picture to the right shows the component parts of a water pump and here we wish to stress a few of the more important points to prevent water pump failure.

Scale and rust throughout the system finds its way to the water pump seal and these sharp particles cause excessive wear of the seal. A complete flushing of the system will help to prevent this.

The fan belt should be able to be flexed inward approximately an inch at a center point between pulleys. See sketch joint A.

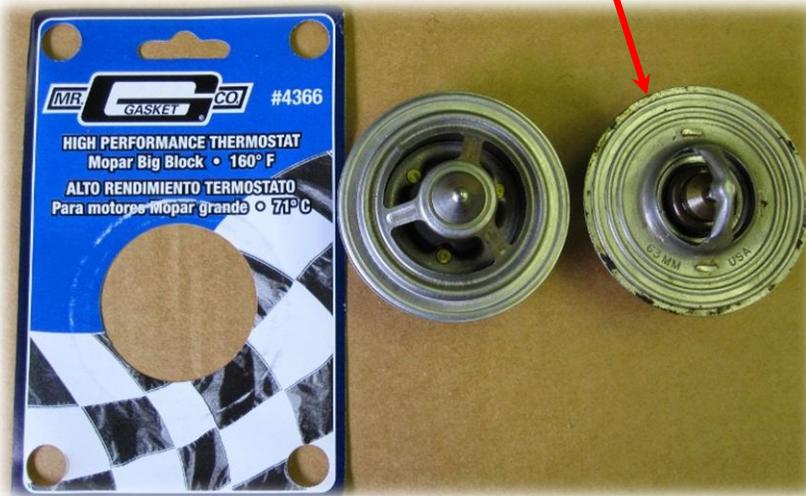
the modern thermostat to function optimally. This is easily done by pressing a 1-1/4" cup style expansion plug into the by-pass opening of the Hudson bypass thermostat housing. That plug will also require drilling a small 1/16 to 1/8" hole through it. This hole will allow air to bleed through the cooling system. The modern thermostat will also require the same size hole drilled through its lip. The pictured thermostats are shown so the differences in opening sizes between a Stant and a Mr. Gasket thermostat can be seen.

When The Mr. Gasket opens is easily is two times the space of the other thermostat. (in other words more coolant flow)

...We did a lot of testing with Stant and Mr. Gasket brand thermostats. As a result of our testing, Mr. Gasket (MG) brand thermostat allowed more coolant flow than the Stant (S) brand. Comparing the 2 different thermostats we found the center orifice in the MG is much larger than S. Inserting both brands in a hot water bath you will observe the MG thermostat mechanical movement opens wider to allow more coolant flow to the Radiator. Using the MG brand in the 1948-54 Hudson engine will necessitate the use of a spacer. (We use the spacer Walt Mordenti sells, it allows the MG to fully open. Otherwise, if the spacer is not used, the rib in the Hudson head used to support the thermostat will inhibit full opening. Also, we observed this rib may be higher in some heads) Effects of the thermostat change were monitored by placing temperature probes directly on the engine head. Temperature readings with and without the spacer were taken. We discovered the spacer and its thickness have another effect on coolant temperature. The spacer allows for improved coolant circulation which in turn created an even temperature front to back in the cylinder head.

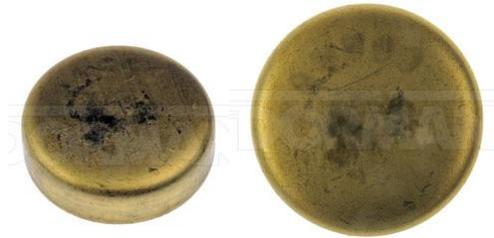
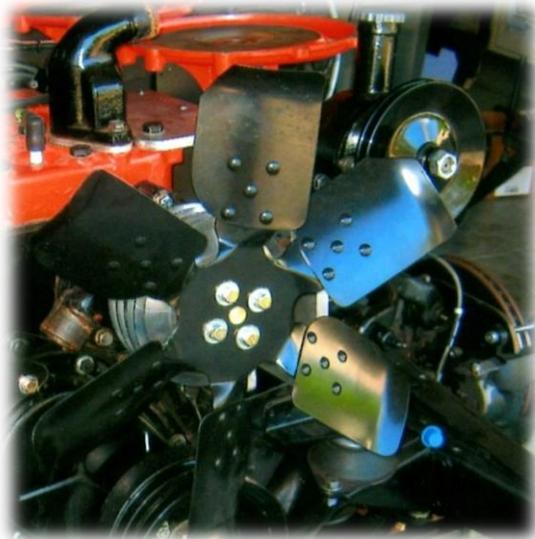
The use of a multi- blade fan to replace the Hudson factory fan will increase the airflow through the radiator at lower speeds

Hudson sealed the spaces around the radiator with rubber or heavy card/fiber board blocks. These like the replacement piece for the space below the radiator (shown) should be checked for integrity and all that are damaged repaired or replaced.

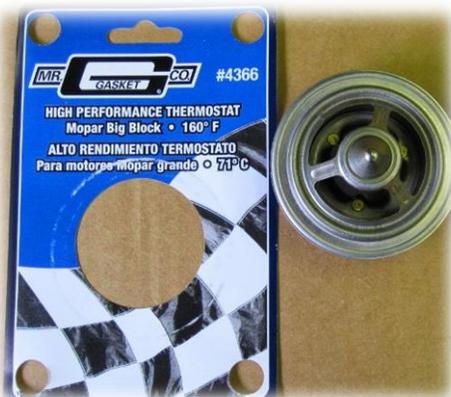
As a result of Rudy's testing, an 8 degree drop in coolant temperature was achieved.

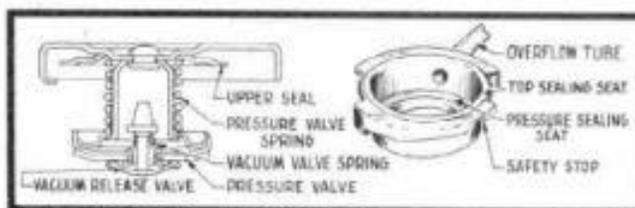
Illustrated below are the sealed coolant cap and the sealing seat in the radiator filler neck. See that there are no nicks that might cause a leak in the sealing seats and that the overflow pipe is free of obstruction. The cams on the outturned flange on the filler neck must not be bent. Likewise, examine the cap for possible break or crack in the upper or lower sealing gasket. Sometimes a cap may become fouled with a sludge of grease and rust. Wash the cap in water or cleaner to remove all dirt.

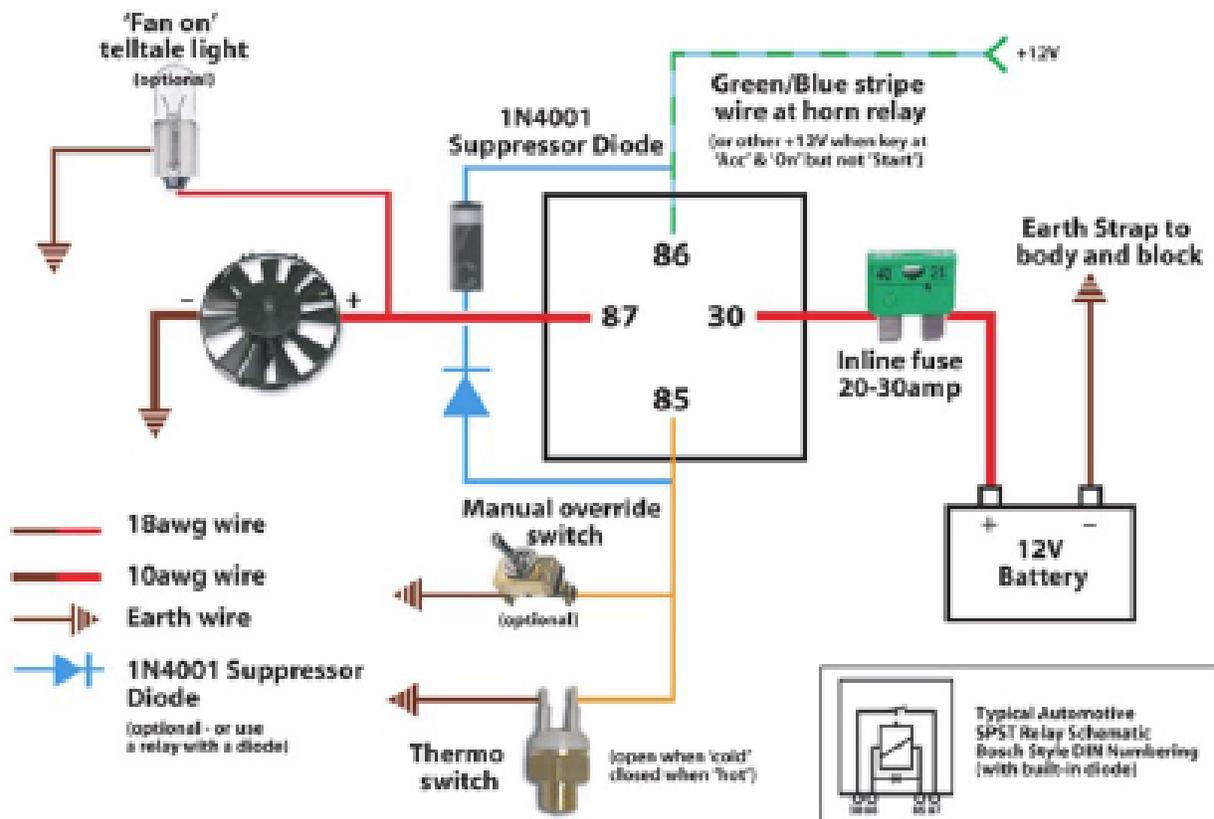
There are a variety of reasons for adding an auxiliary electric fan to your Hudson. The following diagram shows one safe way to wire your fan for reliable operation. This diagram will work for either 6 or 12 volt electrical systems. In the case of 6 volt positive ground systems, make sure that your fan will operate with this type of electrical system
